## TECHNICAL REPORT

**PROPERTY:** **Railway Cart M65451**

**ADDRESS:** **East Lancashire Railway, Bury**

**REPORT TYPE:** **Asbestos Management Survey – 137852**

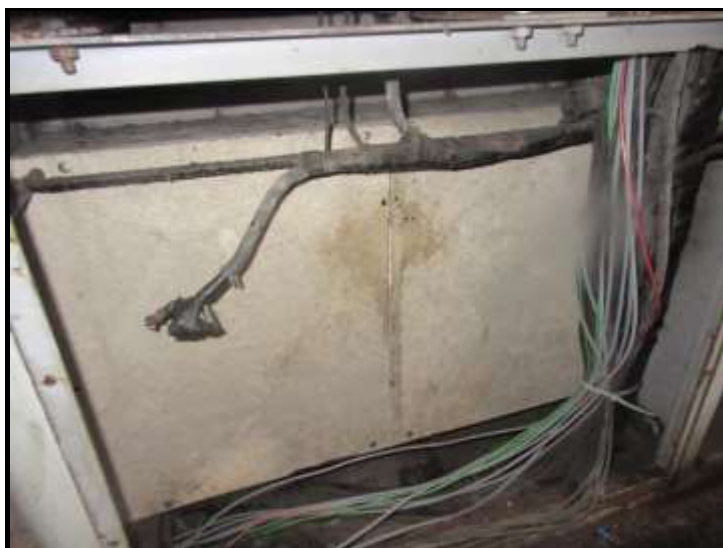
Job Number	137852
Sample Number	S004
Ref Number	46454
Sheet Number:	Page 1 of 3
Sampled By:	Brian Wilson
Date Sampled:	29/02/2012

ACM					
Asbestos Type Description:		Chrysotile		Comments	
Analysis Description:		Significant		Chrysotile	
Material Type:		Insulation board			
Quantity		0.5 Sq mt approx			
Room Number		R003			
Room Description		Drivers room			
Location		Electric Box			
Floor Level		Ground floor			
MATERIAL ASSESSMENT					
Risk Item	Product Type	Damage/Deterioration:	Surface Treatment:	Asbestos Type:	MRS
Risk Points	2	0	1	2	5
Risk Scale	1,2,3	0,1,2,3	0,1,2,3	1,2,3	1 -12

PRIORITY ASSESSMENT					
Risk Item	Material Risk Score	Area Activity	Accessibility	Frequency of use	Maintenance Activity
Risk Points	5	0	0	0	1
Risk Scale	-	0,1,2,3	0,1,2,3	0,1,2,3	0,1,2,3
Priority Risk Score =		6	Risk Category =		D

ACTION		
Action Types	No Action Required	Comments/Recommendations Add to asbestos register and Monitor
Inspection Cycle	3 Monthly	
Removal Priority	High	
Remedial Action	No Action Required

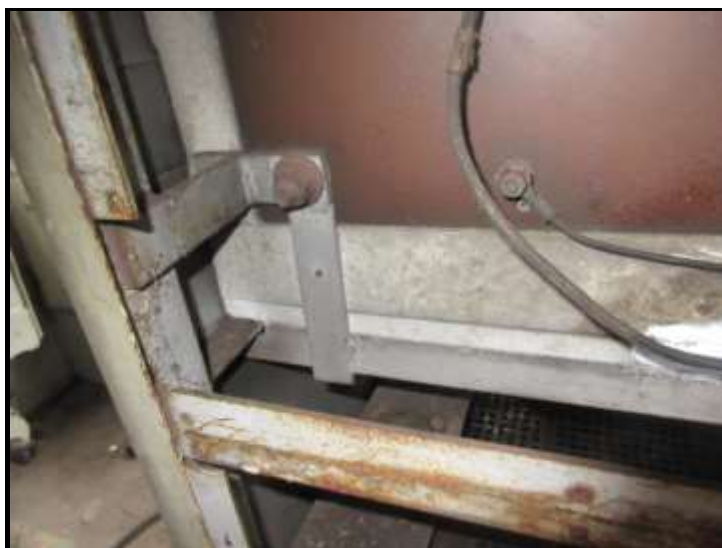
Job Number	137852
Sample Number	S005
Ref Number	46455
Sheet Number:	Page 2 of 3
Sampled By:	Brian Wilson
Date Sampled:	29/02/2012

ACM					
Asbestos Type Description:		Chrysotile		Comments	
Analysis Description:		Significant		Chrysotile - Lining to and behind fuse board	
Material Type:		Cement board			
Quantity		1 Sq mt approx.			
Room Number		R003			
Room Description		Drivers room			
Location		Electric Box			
Floor Level		Ground floor			
MATERIAL ASSESSMENT					
Risk Item	Product Type	Damage/Deterioration:	Surface Treatment:	Asbestos Type:	MRS
Risk Points	1	0	1	1	3
Risk Scale	1,2,3	0,1,2,3	0,1,2,3	1,2,3	1 -12

PRIORITY ASSESSMENT					
Risk Item	Material Risk Score	Area Activity	Accessibility	Frequency of use	Maintenance Activity
Risk Points	3	0	0	0	1
Risk Scale	-	0,1,2,3	0,1,2,3	0,1,2,3	0,1,2,3
Priority Risk Score =		4	Risk Category =		D

ACTION		
Action Types	No Action Required	Comments/Recommendations Add to asbestos register and Monitor
Inspection Cycle	6 Monthly	
Removal Priority	Medium	
Remedial Action	No Action Required

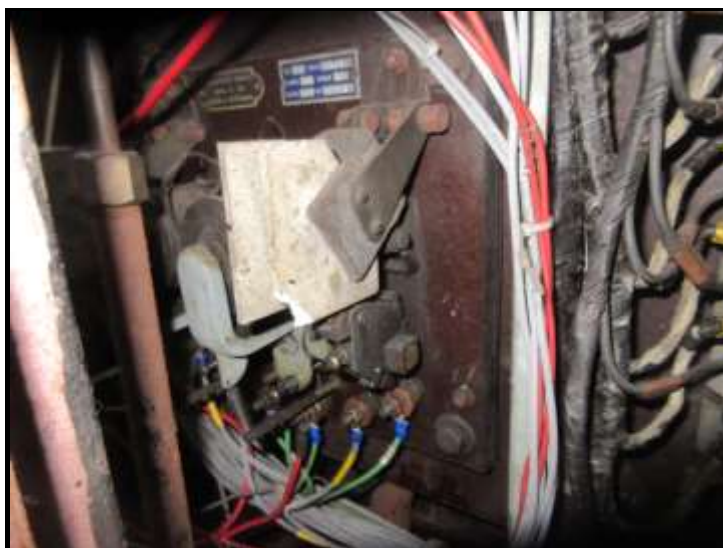
Job Number	137852
Sample Number	S006
Ref Number	46456
Sheet Number:	Page 3 of 3
Sampled By:	Brian Wilson
Date Sampled:	29/02/2012

ACM					
Asbestos Type Description:		Chrysotile		Comments	
Analysis Description:		Significant		Chrysotile	
Material Type:		Cement board			
Quantity		Typical			
Room Number		R004			
Room Description		Drivers room			
Location		Electrical switch gear			
Floor Level		Ground floor			
MATERIAL ASSESSMENT					
Risk Item	Product Type	Damage/Deterioration:	Surface Treatment:	Asbestos Type:	MRS
Risk Points	1	0	0	1	2
Risk Scale	1,2,3	0,1,2,3	0,1,2,3	1,2,3	1 -12

PRIORITY ASSESSMENT					
Risk Item	Material Risk Score	Area Activity	Accessibility	Frequency of use	Maintenance Activity
Risk Points	2	0	0	0	1
Risk Scale	-	0,1,2,3	0,1,2,3	0,1,2,3	0,1,2,3
Priority Risk Score =		3	Risk Category =		D

ACTION		
Action Types	No Action Required	Comments/Recommendations Add to asbestos register and Monitor
Inspection Cycle	12 Monthly	
Removal Priority	Low	
Remedial Action	No Action Required
